FAWN LAKE DAM

PHASE I INSPECTION REPORT
NATIONAL DAM INSPECTION PROGRAM

NDI PA 00309
PA DER 52-168

FEBRUARY 1979

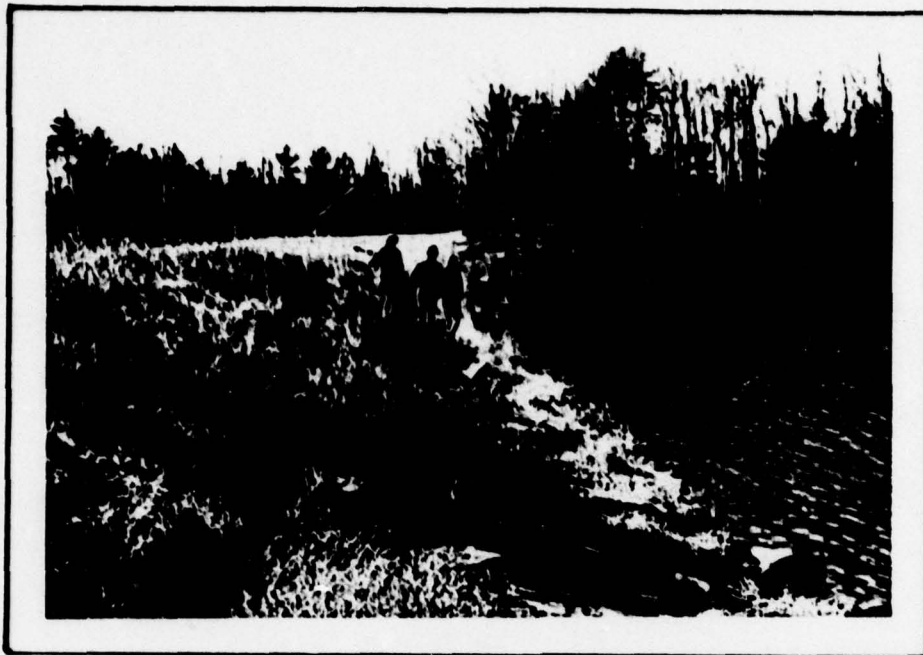
b. Dam. The riprap on the upstream face of the embankment is a poorly graded mix of large, relatively flat, angular rocks and smaller stone. There is little uniformity in the distribution and placement of the rock. Small bushes and animal burrow holes are located at several points along the upstream face.

An undulating depression was observed along the upstream face of the dam, about 1 to 3 feet from the top of dam. The depression extends across much of the embankment parallel to the crest. The depression varies in depth from a few inches to more than 2 feet. Field measurements of the top of dam and both side slopes reveal no inconsistencies with the design drawings.

UPSTREAM FACE OF DAM

1. The riprap on the upstream face of the dam is poorly graded, unevenly distributed, and provides inadequate coverage. The riprap should be supplemented to provide a well graded, evenly distributed layer of slope protection extending to the top of dam.
2. A longitudinal depression extends across the upstream face of the embankment. The depression varies in depth from a few inches to more than 2 feet. Another depression was observed along the left abutment parallel to the left training wall. These depressions should be monitored to determine if any differential movement occurs.
3. Animal burrow holes and several small bushes were observed on the upstream face of the embankment. The animal holes should be filled with suitable material, and the bushes removed.

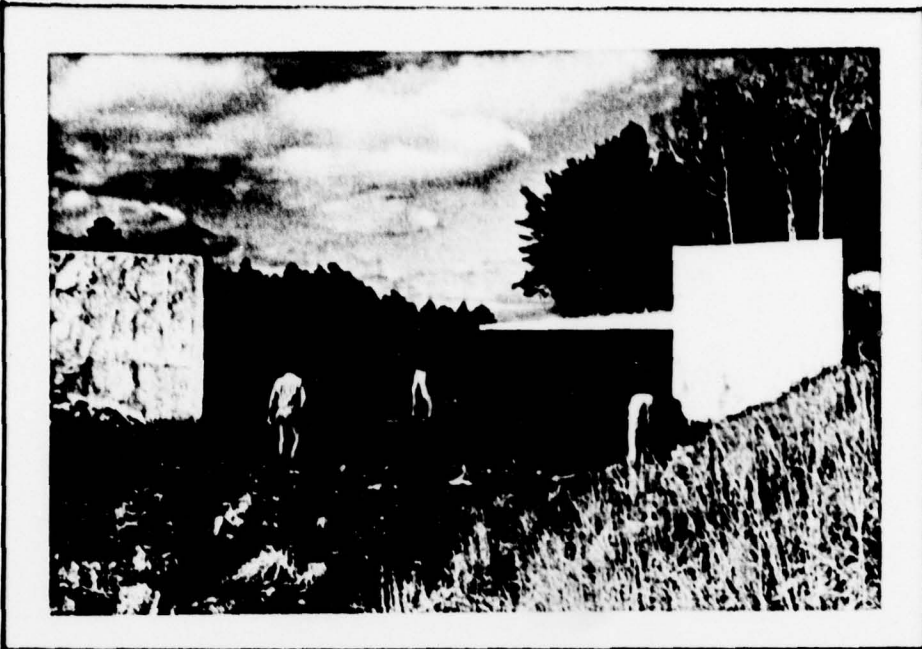
c. Appurtenant Structures. The concrete overflow spillway adjoins the left abutment. The silt level at the spillway is approximately 3 feet below the spillway crest. The top foot of the spillway crest appears to have been formed separately from the underlying concrete. The contact area between the two pours has a rough surface which is evident across the entire spillway. Minor spalling of concrete surfaces has occurred at several construction joints on the training walls adjoining the spillway. The apron downstream of the spillway is a trapezoid in plan view, as shown on Plate 4. Weep holes are located at approximately 10-foot intervals along each training wall. No flow was observed from any of the weep holes. At the downstream end of the apron, there is a 2-foot drop to the bed of the grouted riprap discharge channel. Some minor spalling of concrete was noted at the contact between the apron and channel.

Based on the field inspection, the concrete spillway shows no signs of structural instability or deterioration of concrete surfaces. According to the design drawings, reinforcing bars join the spillway and the apron, and construction joints tie the spillway into the training walls.

SPILLWAY AND STILLING BASIN

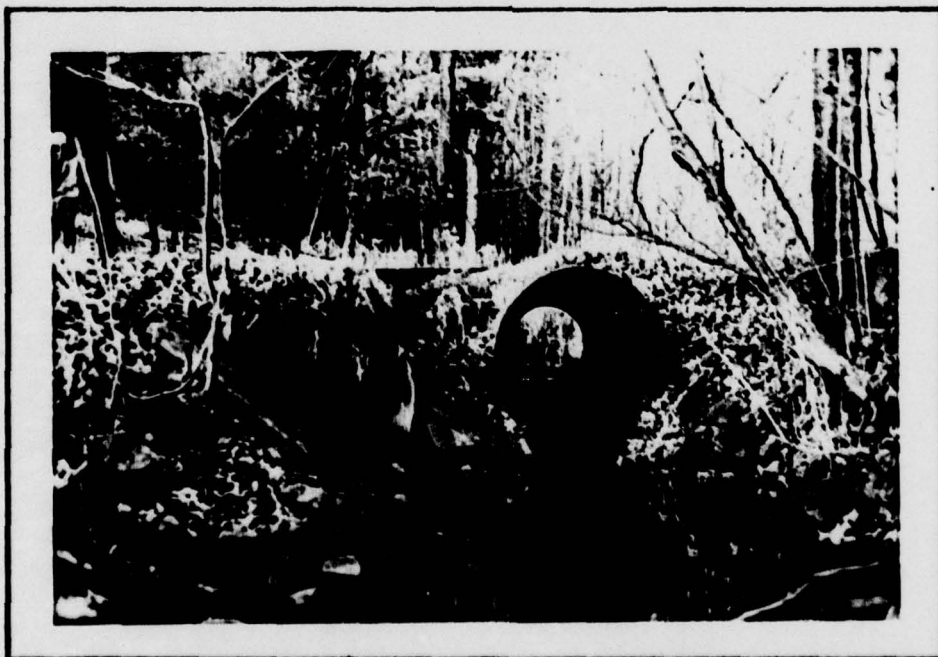
ROADWAY 1500 FEET DOWNSTREAM OF DAM

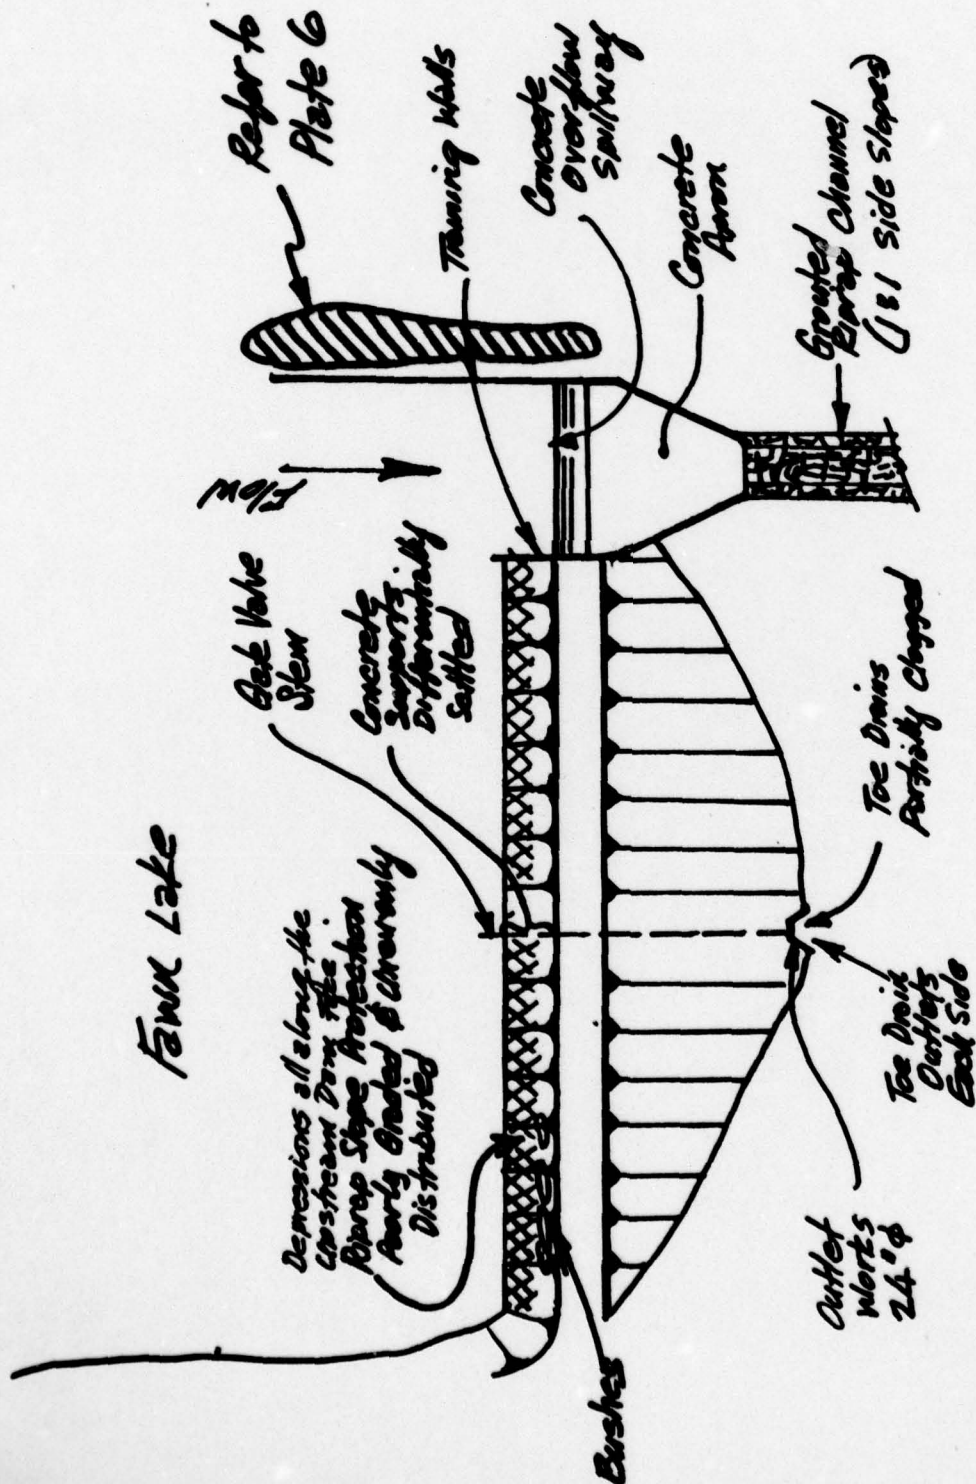
PLATE 2

FAWN LAKE DAM
General Plan of Features
with Inspection Notes
